## **ASBESTOS BUILDING INSPECTION**

**WINDSOR CASTLE AND ASSOCIATED STRUCTURES  
301 JERICO ROAD  
SMITHFIELD, VA 23430**

**THE TOWN OF SMITHFIELD  
P. O. BOX 246  
SMITHFIELD, VA 23431**

Report Number: ALS 15-10733  
10 February 2015

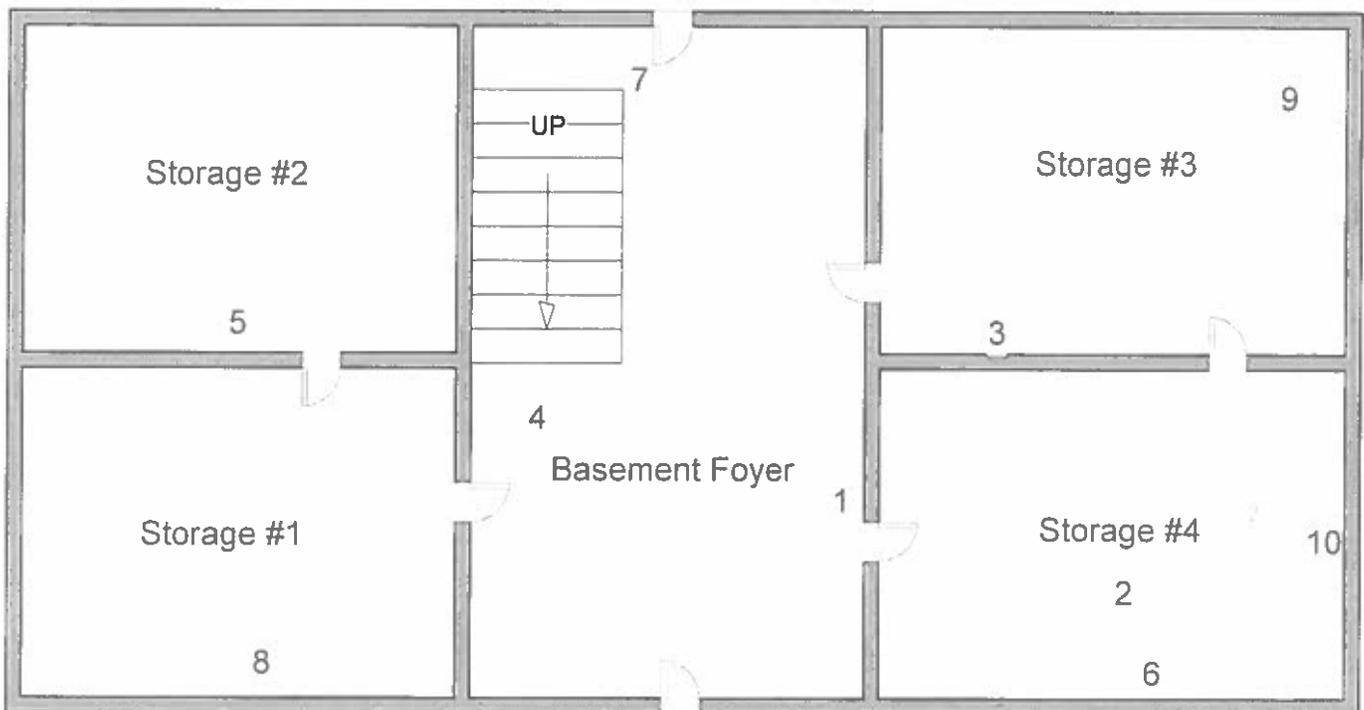
Asbestos Inspection  
Sample Location Diagram  
Windsor Castle  
Manor House  
February 4, 2015

Sample #	Sample Description	Sample Location	Quantity	*Condition G/D/SD	Friable Y/N
1	Sheet Flooring, Pattern Brick	Basement Foyer	742 SF	G	N
2	Sheet Flooring, Pattern Brick	Storage 3	Refer to #1	SD	N
3	Sheet Flooring, Pattern Brick	Closet, Storage 4	Refer to #1	D	N
4	Wall Plaster over Brick	Basement Foyer	3120	SD	Y
5	Wall Plaster over Brick	Storage 2	refer to #4	SD	Y
6	Wall Plaster over Brick	Storage 3	refer to #4	SD	Y
7	Ceiling Plaster	Basement foyer	500SF	SD	Y
8	Ceiling Plaster	Storage 1	refer to #7	SD	Y
9	Ceiling Plaster	Storage 4	refer to #7	SD	Y
10	Fireplace Mortar	Storage 3	50SF	G	Y

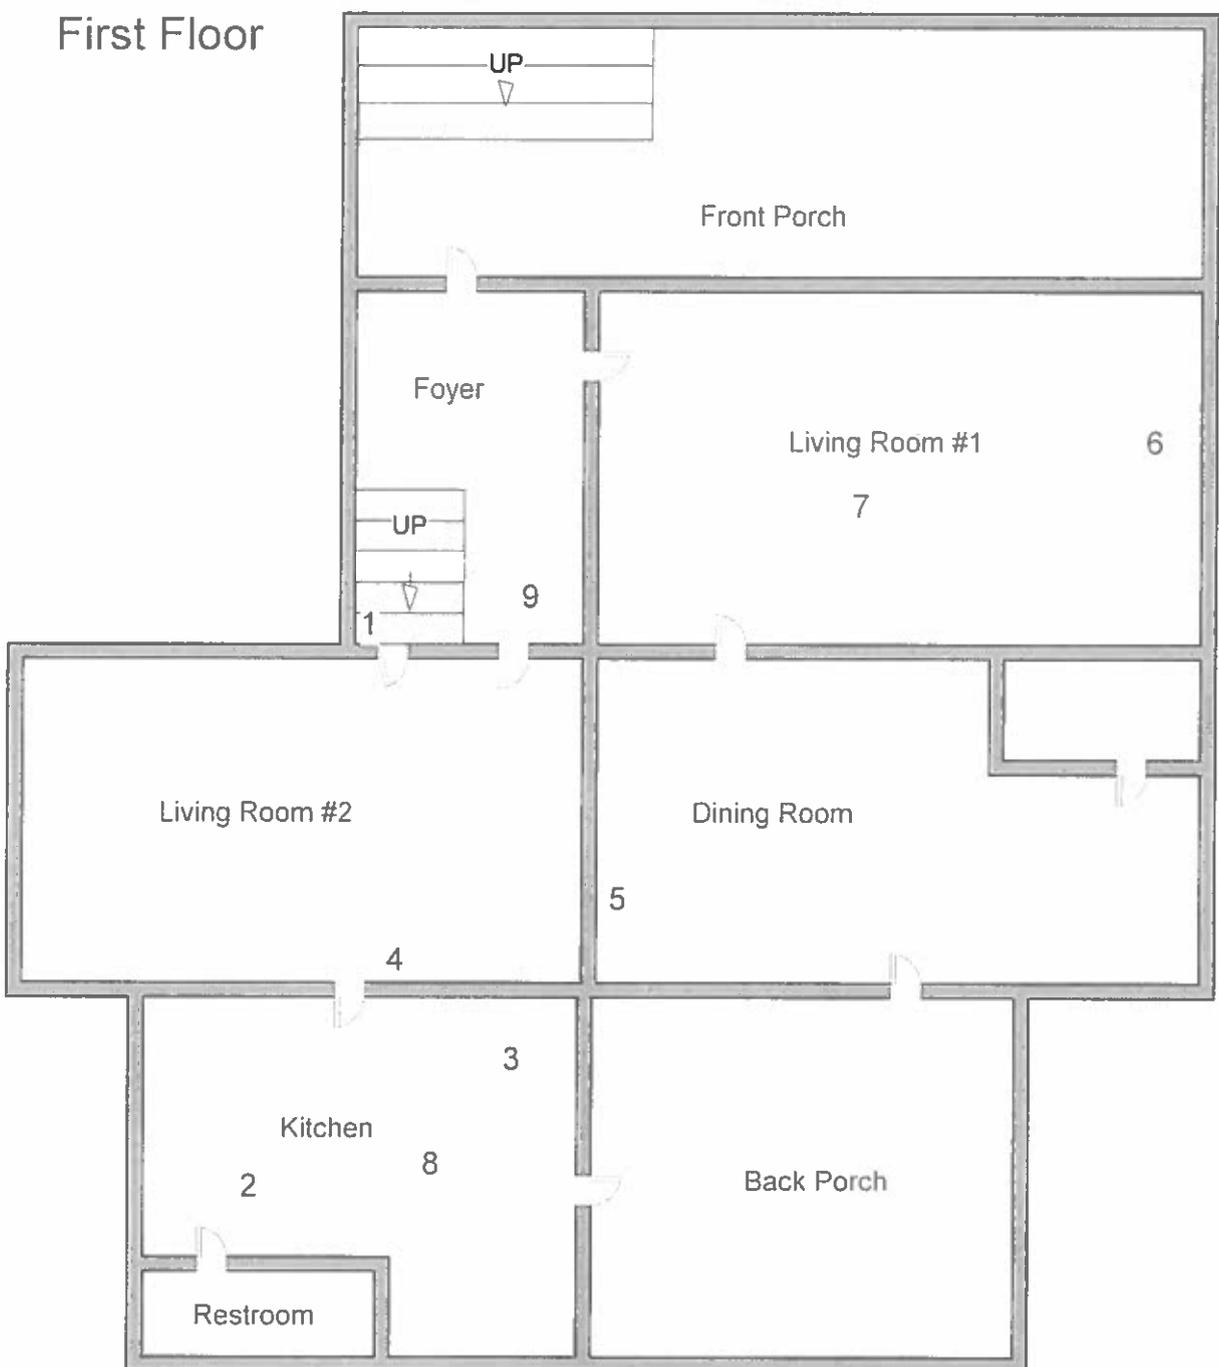
# Asbestos Inspection Sample Location Diagram Windsor Castle Caretaker's House February 4, 2015

Sample #	Sample Description	Sample Location	Quantity	*Condition G/D/SD	Friable Y/N
1	Carpet Backing	Closet under stairs	200 SF	G	N
2	Sheet Flooring	Kitchen	150 SF	D	N
3	White Sink Mastic	Kitchen	60 SF	G	N
4	Wall Plaster	Living Room 2	4000 SF	SD	Y
5	Wall Plaster	Dining Room	refer to #4	D	Y
6	Wall Plaster	Living Room 1	refer to #4	SD	Y
7	Ceiling Plaster	Living Room 1	1350 SF	SD	Y
8	Ceiling Plaster	Kitchen	refer to #7	SD	Y
9	Drywall ceiling	Foyer	100 SF	SD	Y
10	Sheet Flooring, <sup>white</sup> tile pattern	2nd Fl Restroom	603 SF	SD	N

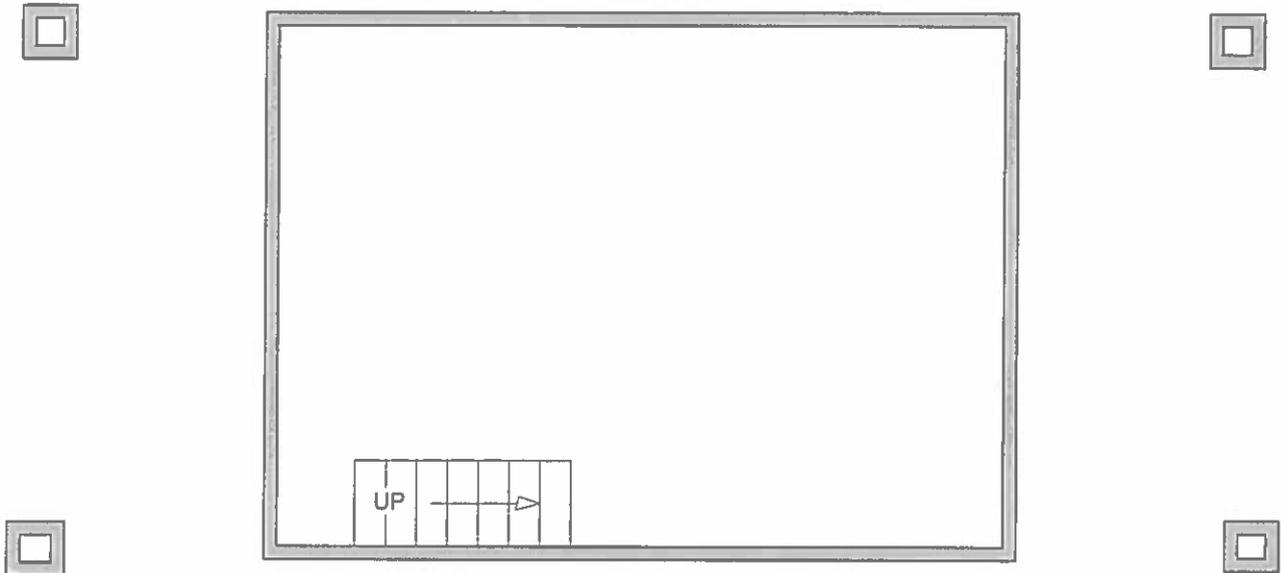
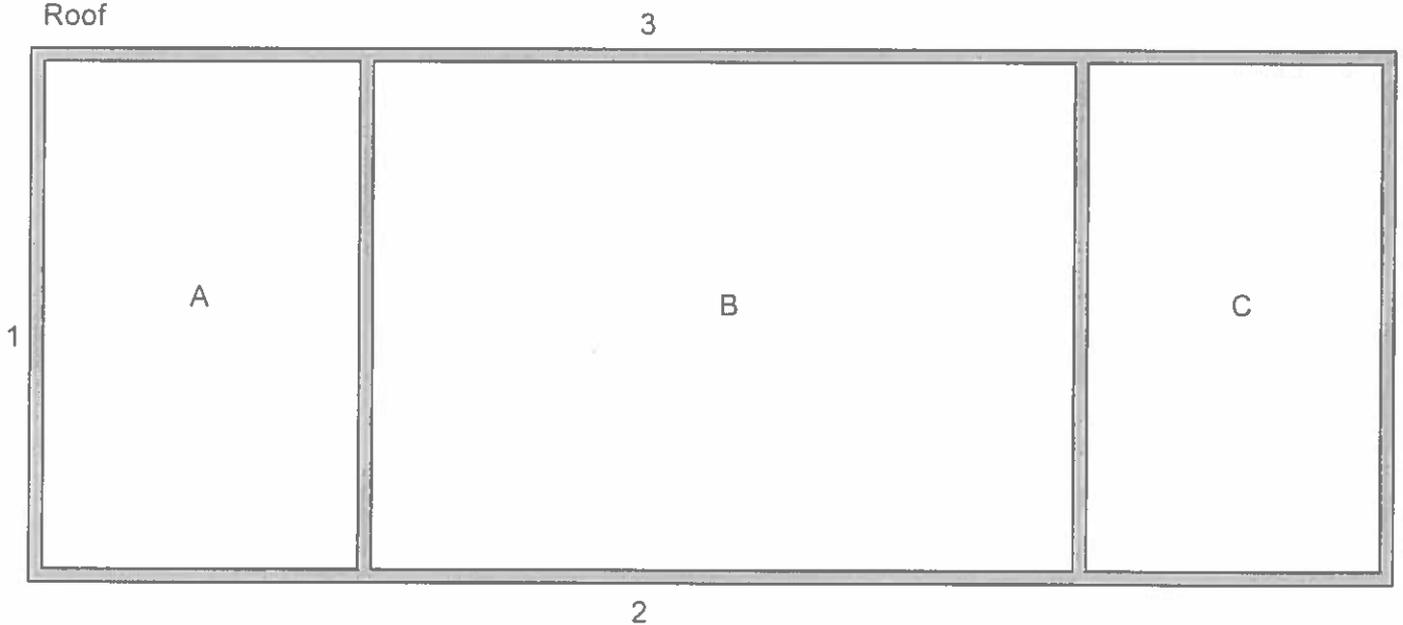
Asbestos Inspection  
Sample Location Diagram  
Windsor Castle  
Crib  
February 6, 2015

Sample #	Sample Description	Sample Location	Quantity	*Condition G/D/SD	Friable Y/N
1	Silver Coat	Roof A	1300SF	G	N
2	Silver Coat	Roof B	refer to #1 <del>1300SF</del>	G	N
3	Silver Coat	Roof B	refer to #1	G	N

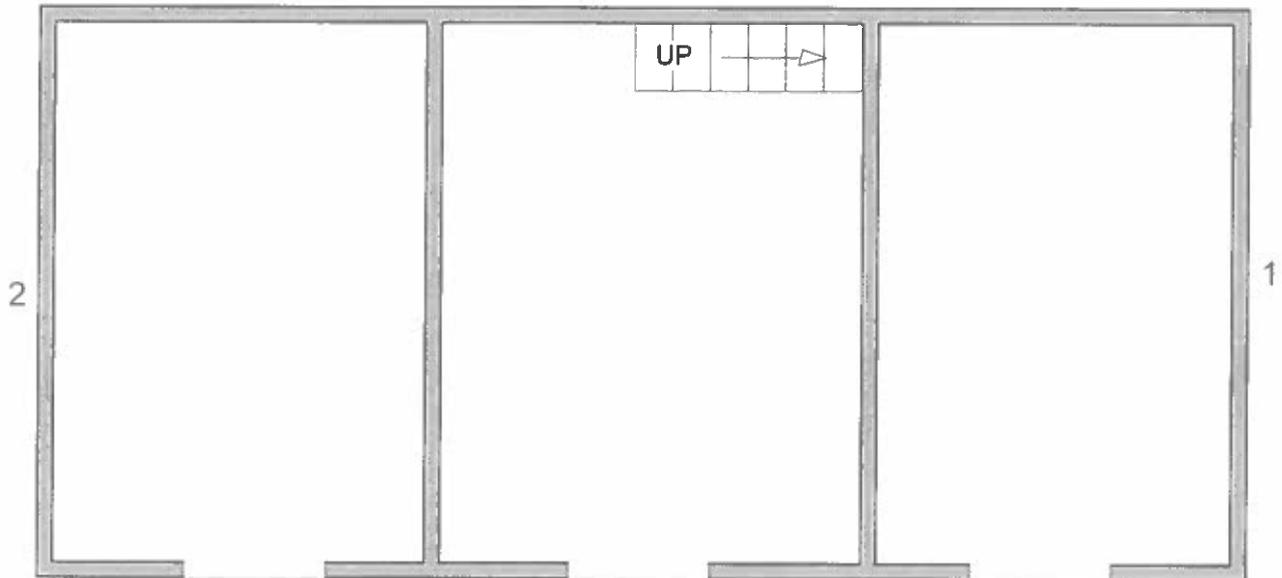
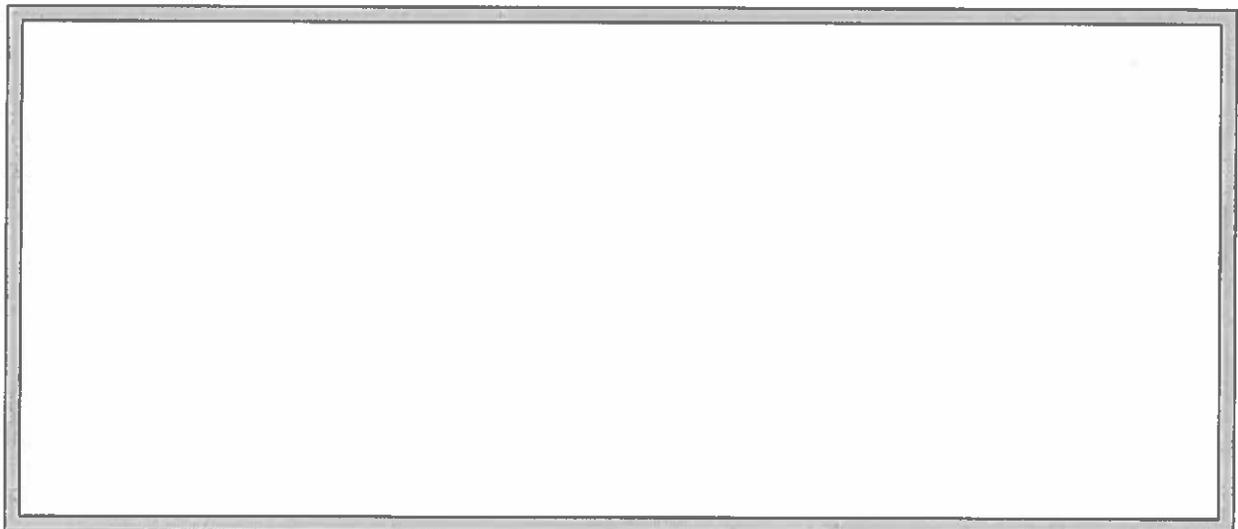
Asbestos Inspection  
Sample Location Diagram  
Windsor Castle  
West Peanut Barn  
February 6, 2015

Sample #	Sample Description	Sample Location	Quantity	*Condition G/D/SD	Friable Y/N
1	SILVER COAT	ROOF	1500 SF	G	N
2	SILVER COAT	ROOF	REFER TO #1	G	N

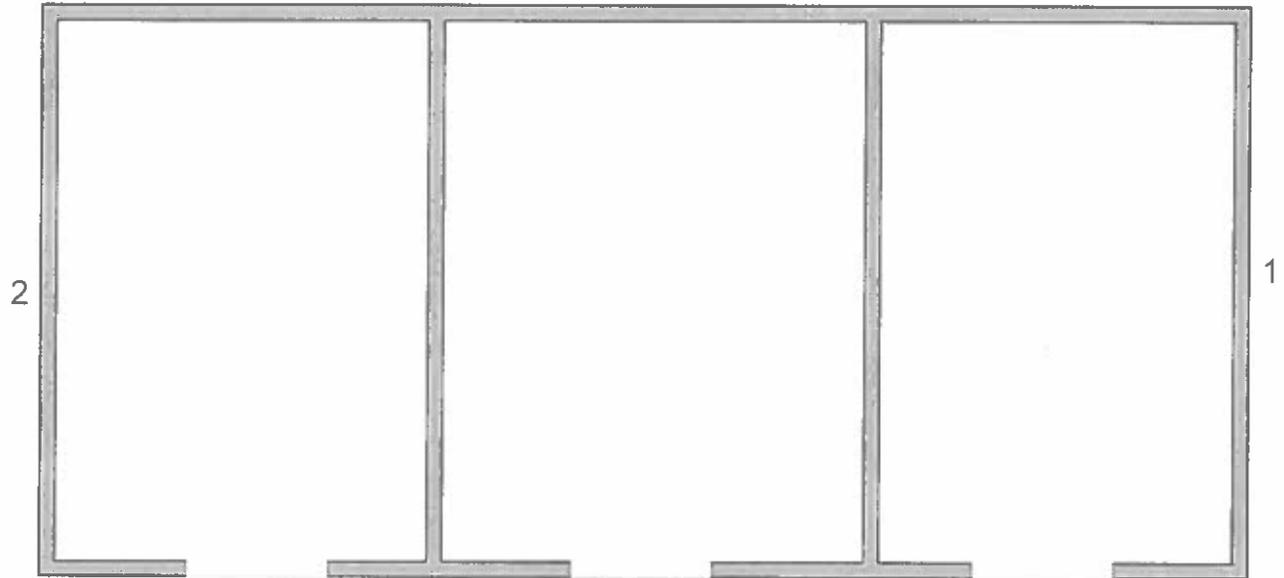
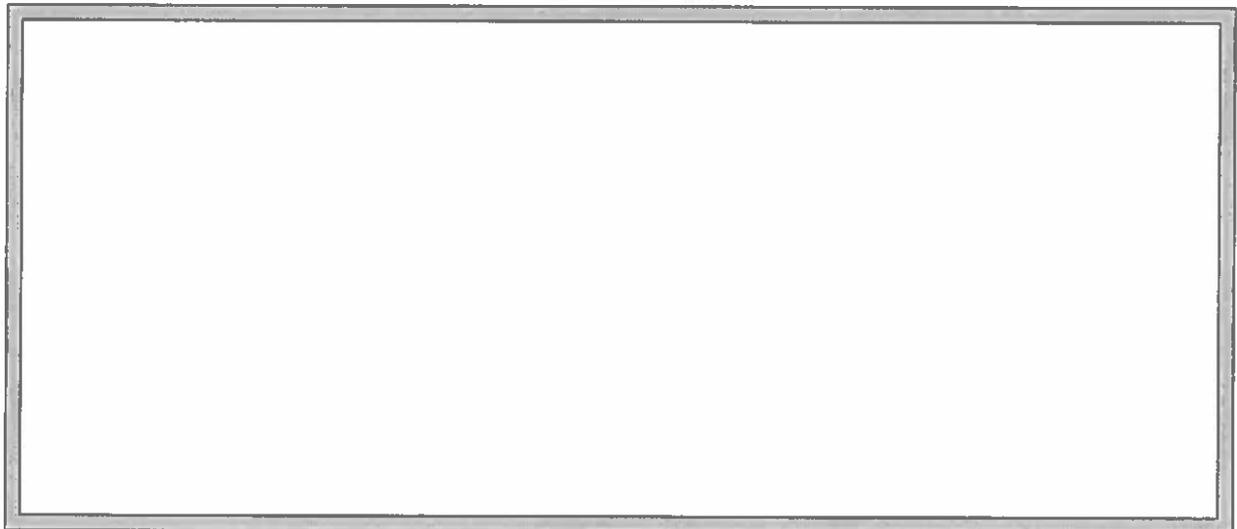
Asbestos Inspection  
Sample Location Diagram  
Windsor Castle  
East Peanut Barn  
February 6, 2015

Sample #	Sample Description	Sample Location	Quantity	*Condition G/D/SD	Friable Y/N
1	SILVER COAT	ROOF	1500 SF	G	N
2	SILVER COAT	ROOF	REFER TO #1	G	N

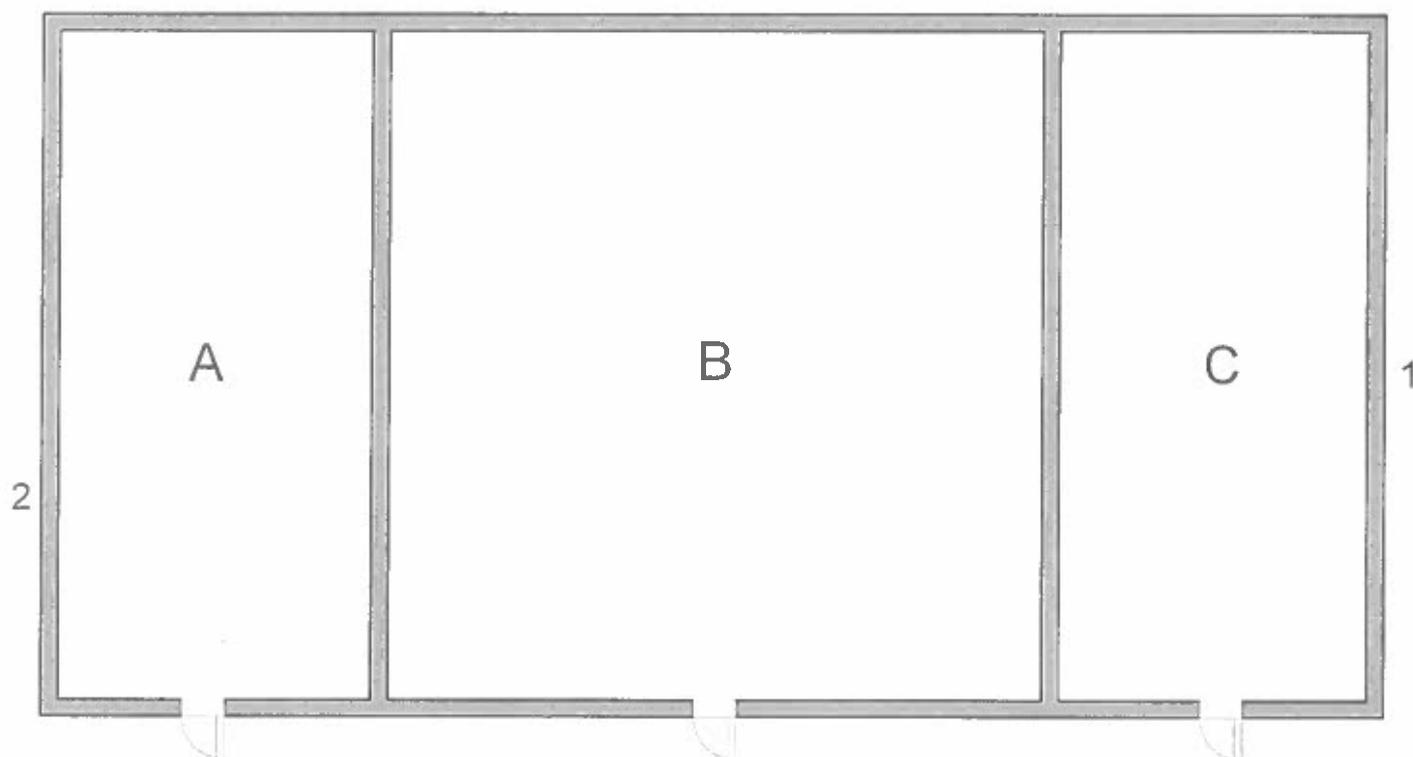
Asbestos Inspection  
Sample Location Diagram  
Windsor Castle  
Corn Crib  
February 4, 2015

Sample #	Sample Description	Sample Location	Quantity	*Condition G/D/SD	Friable Y/N
1	SILVER COAT	ROOF	500 SF	G	<del>Y</del> N
2	SILVER COAT	ROOF	REFER TO #1	G	N

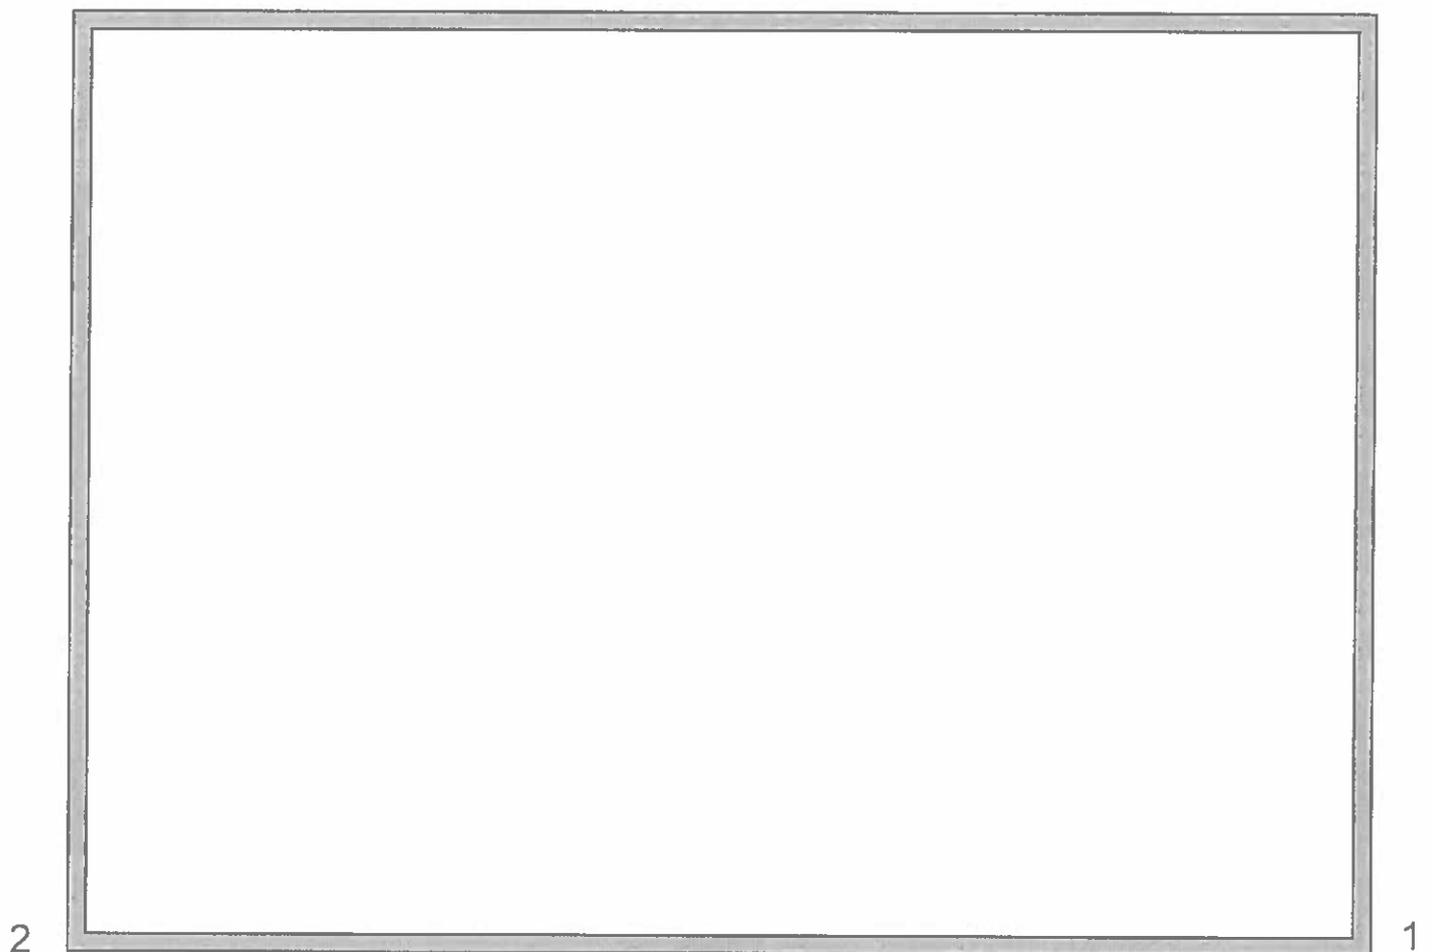
Asbestos Inspection  
Sample Location Diagram  
Windsor Castle  
Pole Barn  
February 6, 2015

Sample #	Sample Description	Sample Location	Quantity	*Condition G/D/SD	Friable Y/N
1	Silver Coat	Roof	2100 SF	G	Y
2	Silver Coat	Roof	refer to #1	G	Y

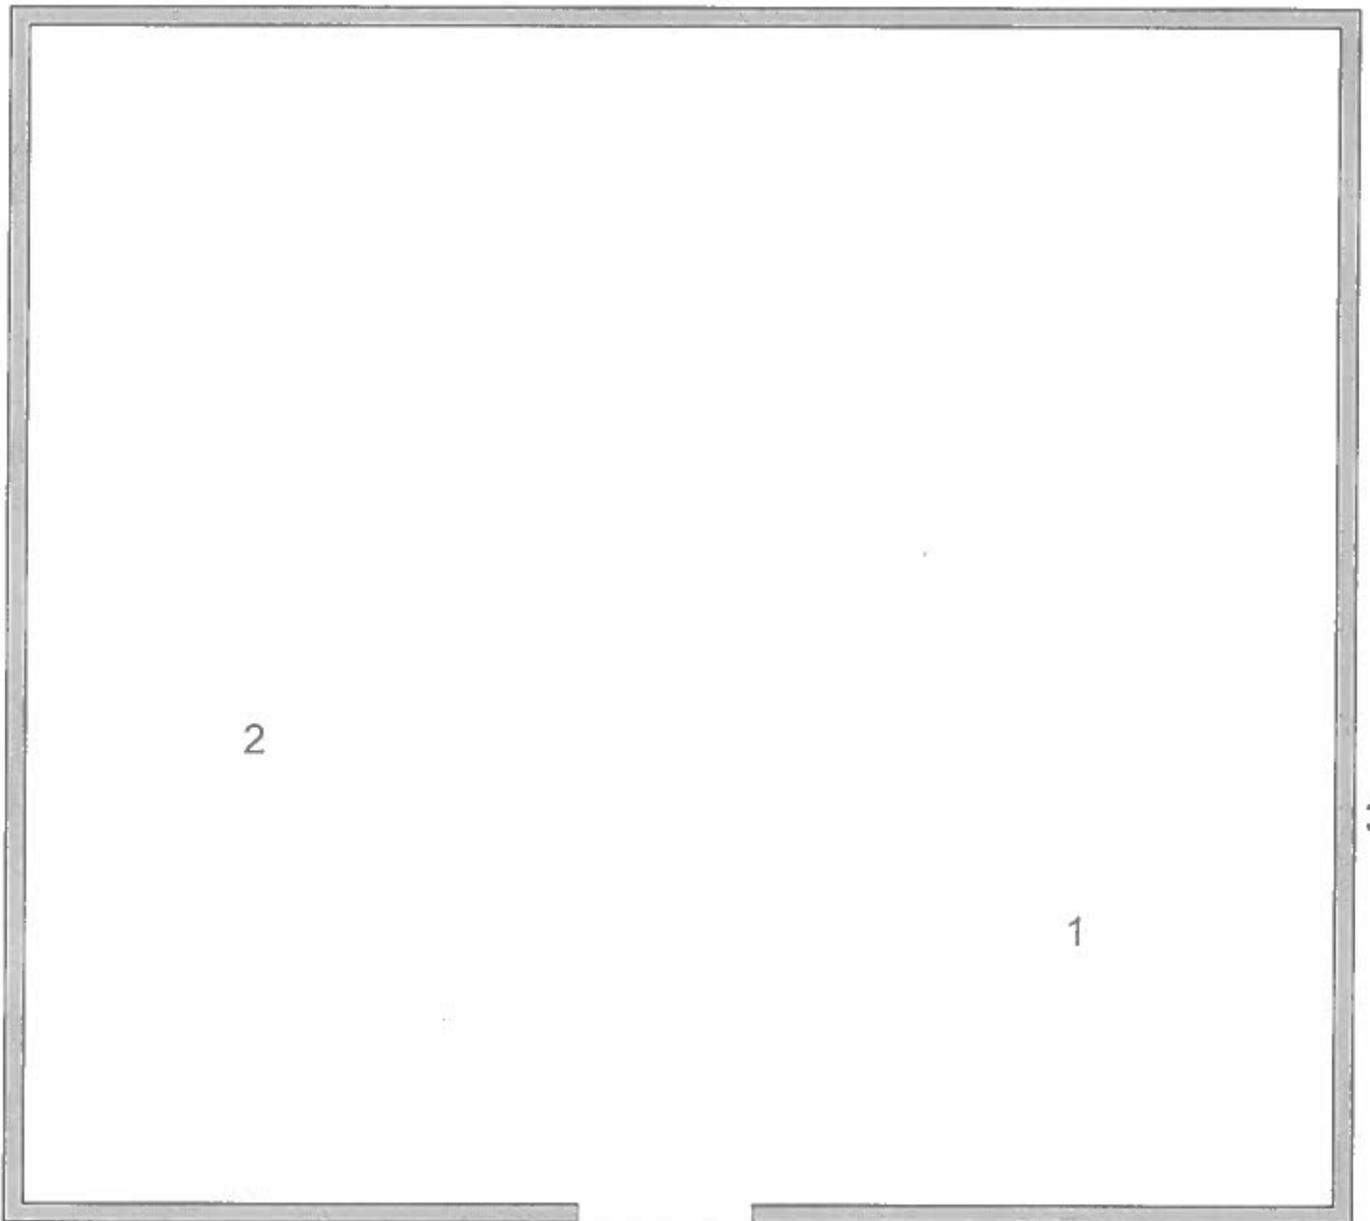
Asbestos Inspection  
Sample Location Diagram  
Windsor Castle  
Farm Office  
February 6, 2015

Sample #	Sample Description	Sample Location	Quantity	*Condition G/D/SD	Friable Y/N
1	Sheet Flooring, green	Main Room	250 SF	D	N
2	2'x4' ceiling tiles	Main Room	250 SF	SD	Y
3	Window Glaze	EXTERIOR	50 LF	SD	N

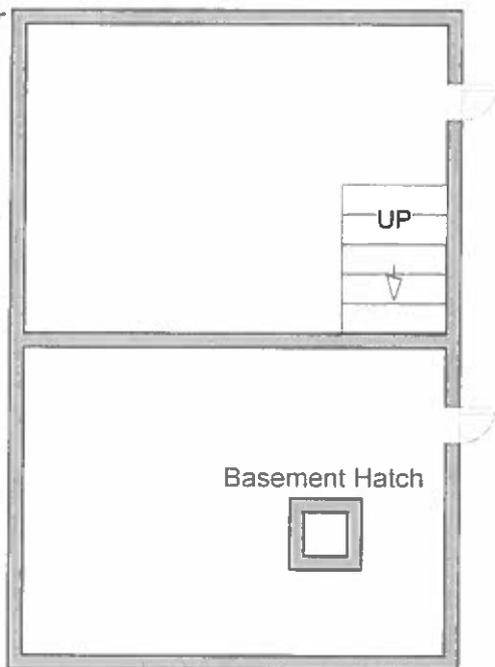
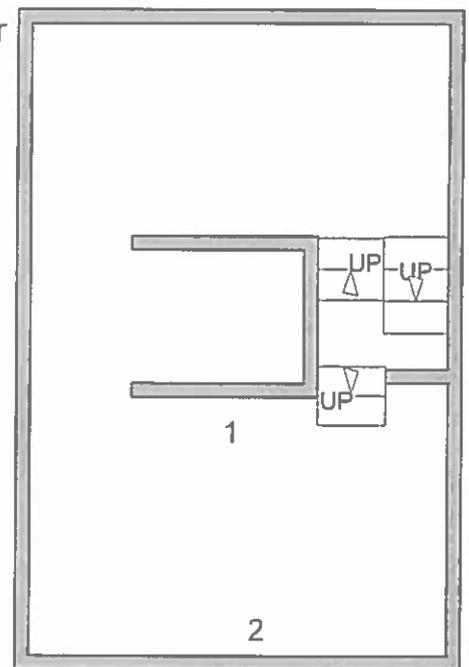
# Asbestos Inspection Sample Location Diagram Windsor Castle Outside Kitchen February 4, 2015

Sample #	Sample Description	Sample Location	Quantity	*Condition G/D/SD	Friable Y/N
1	Wall Plaster	Attic	20 SF	SP	Y
2	<del>Exterior</del> Window glaze	Exterior	210 LF	SD	N

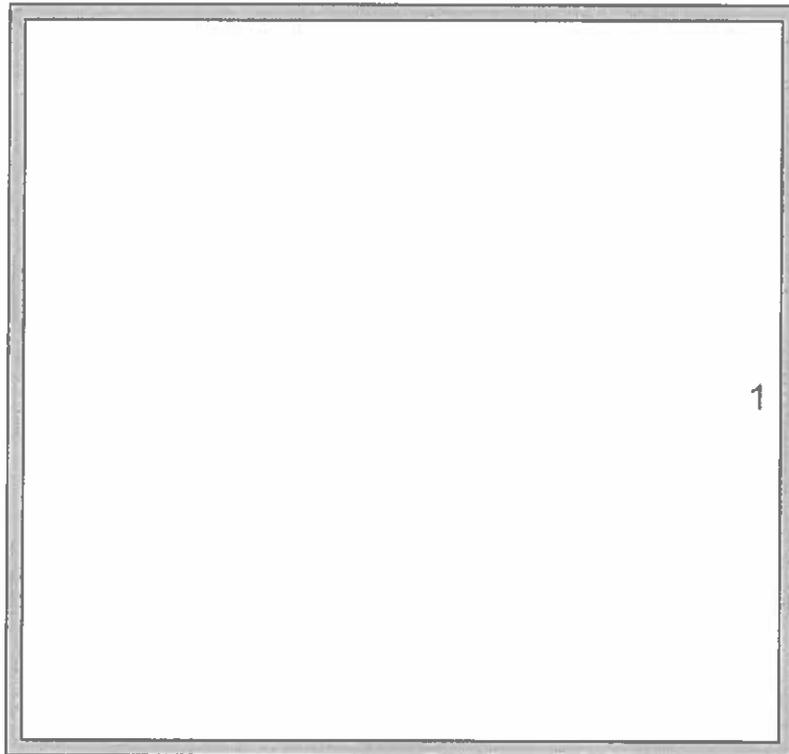
Asbestos Inspection  
Sample Location Diagram  
Windsor Castle  
Carport Adjacent to Outside Kitchen  
February 6, 2015

Sample #	Sample Description	Sample Location	Quantity	*Condition G/D/SD	Friable Y/N
1	Tar paper sublayer	Roof	200 SF	SD	N

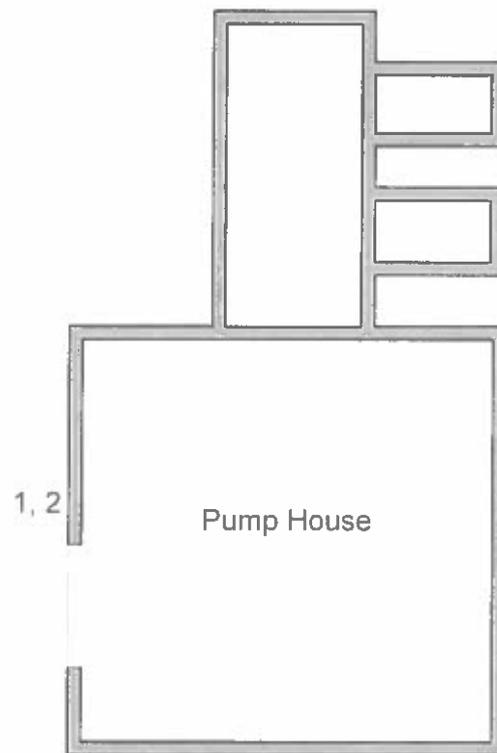
Asbestos Inspection  
Sample Location Diagram  
Windsor Castle  
Pump Station and Machinery Cover  
February 6, 2015

Sample #	Sample Description	Sample Location	Quantity	*Condition G/D/SD	Friable Y/N
1	SHINGLE SUBLAYER	PUMP HOUSE ROOF	50 SF	PG	N
2	TAR PAPER SUBLAYER	PUMP HOUSE ROOF	50 SF	G	N
3	SILVER COAT	ASSOCIATED MACHINERY COVER ROOF	30 SF	G	N
